Inspection Report - Profile

BAMR Example\Pipeline #234\
Surface Profile

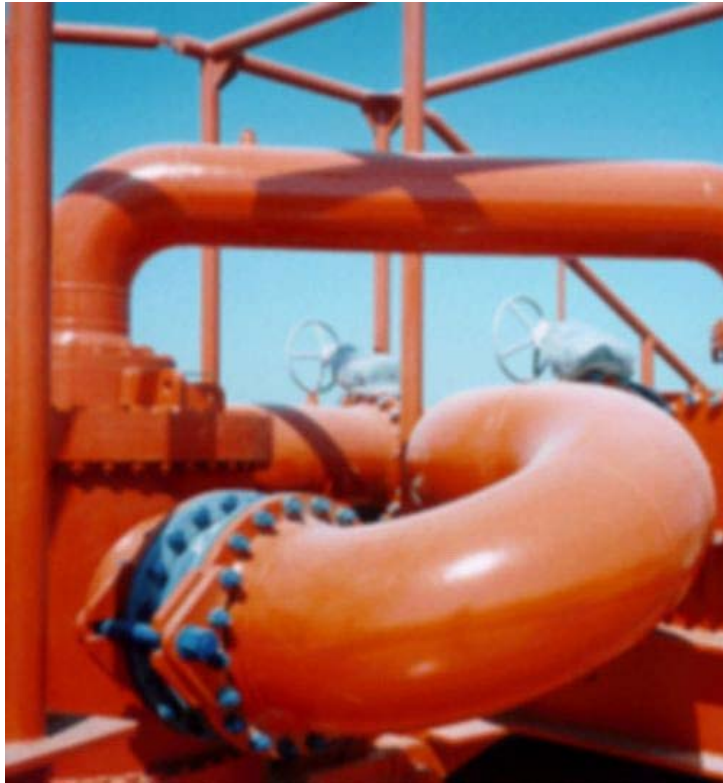
Image.jpg

Gauge Type	Elcometer 223
Profile Type	Grit Blasted
Cleanliness	SA2.5
